MISCELLANEOUS PAPER HL-86-6

ST. STEPHEN POWERHOUSE TAILRACE VELOCITY MEASUREMENT

T. L. Fagerburg

September 1986

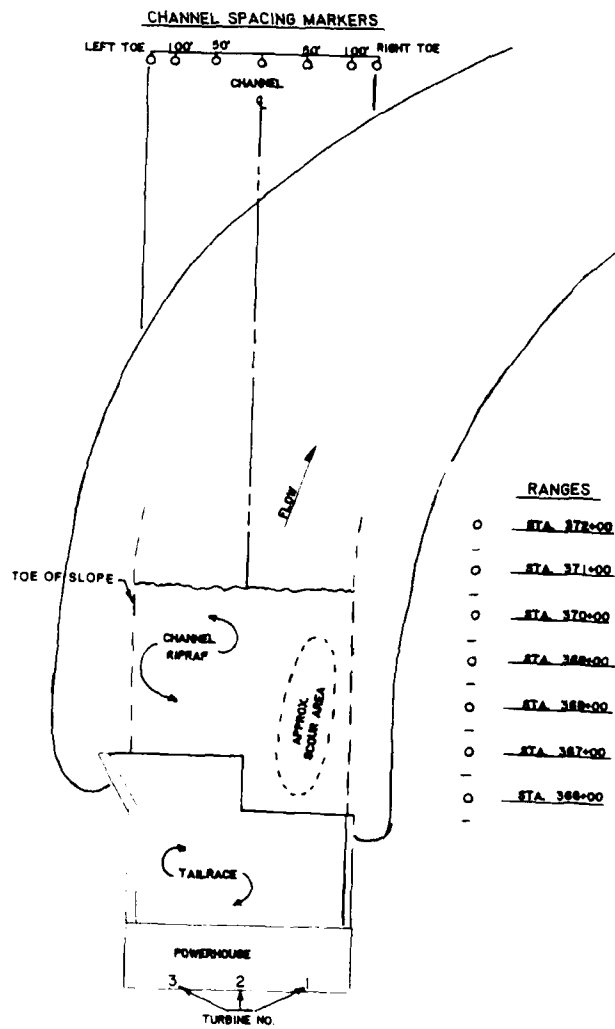
Figure 1. Range and channel spacing markers

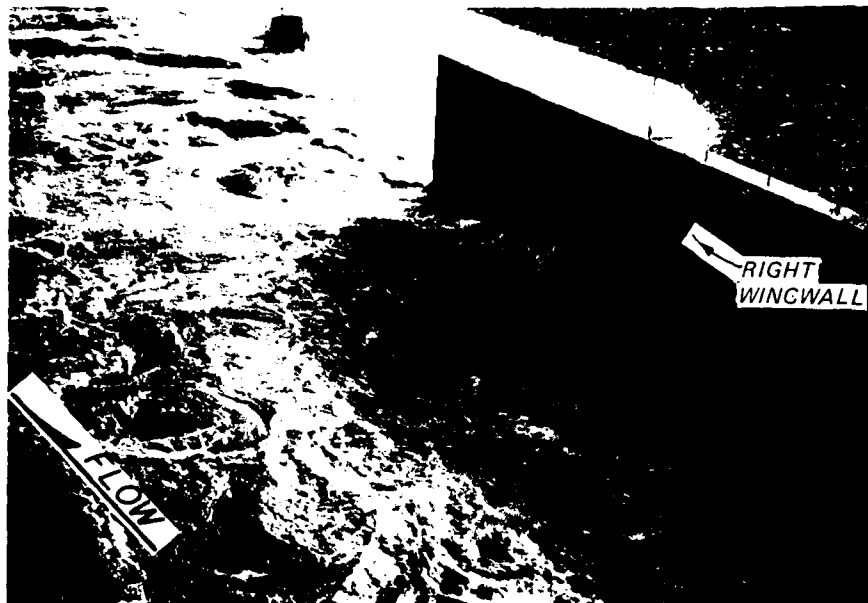
11. A few spot velocity measurements were attempted at a location immediately downstream of the right wing wall. Due to extreme turbulence, standing waves, and critical surface currents in this area, as shown in Figure 4, and difficulty in maintaining boat position, these efforts were discontinued after a few attempts. Therefore, the spot velocity information obtained in this area during the test period should be interpreted for determination of trends and not considered as absolute values. Velocity readings taken at all other locations are considered to be accurate to within ± 0.2 fps.

Figure 4. Flow turbulence in the area of the right wing wall
